Engineering Services  
Instrumentation Monitoring  
Report for the Arecibo Municipal Solid Waste Landfill

Prepared by GEO-Engineering Services, Inc.  
Under Contract No. G-100-17-0001, dated March 16, 2018.

Re: Instrumentation Monitoring for  
Municipal Solid Waste Landfill  
Arecibo, Puerto Rico  
(GEO-853-2014)

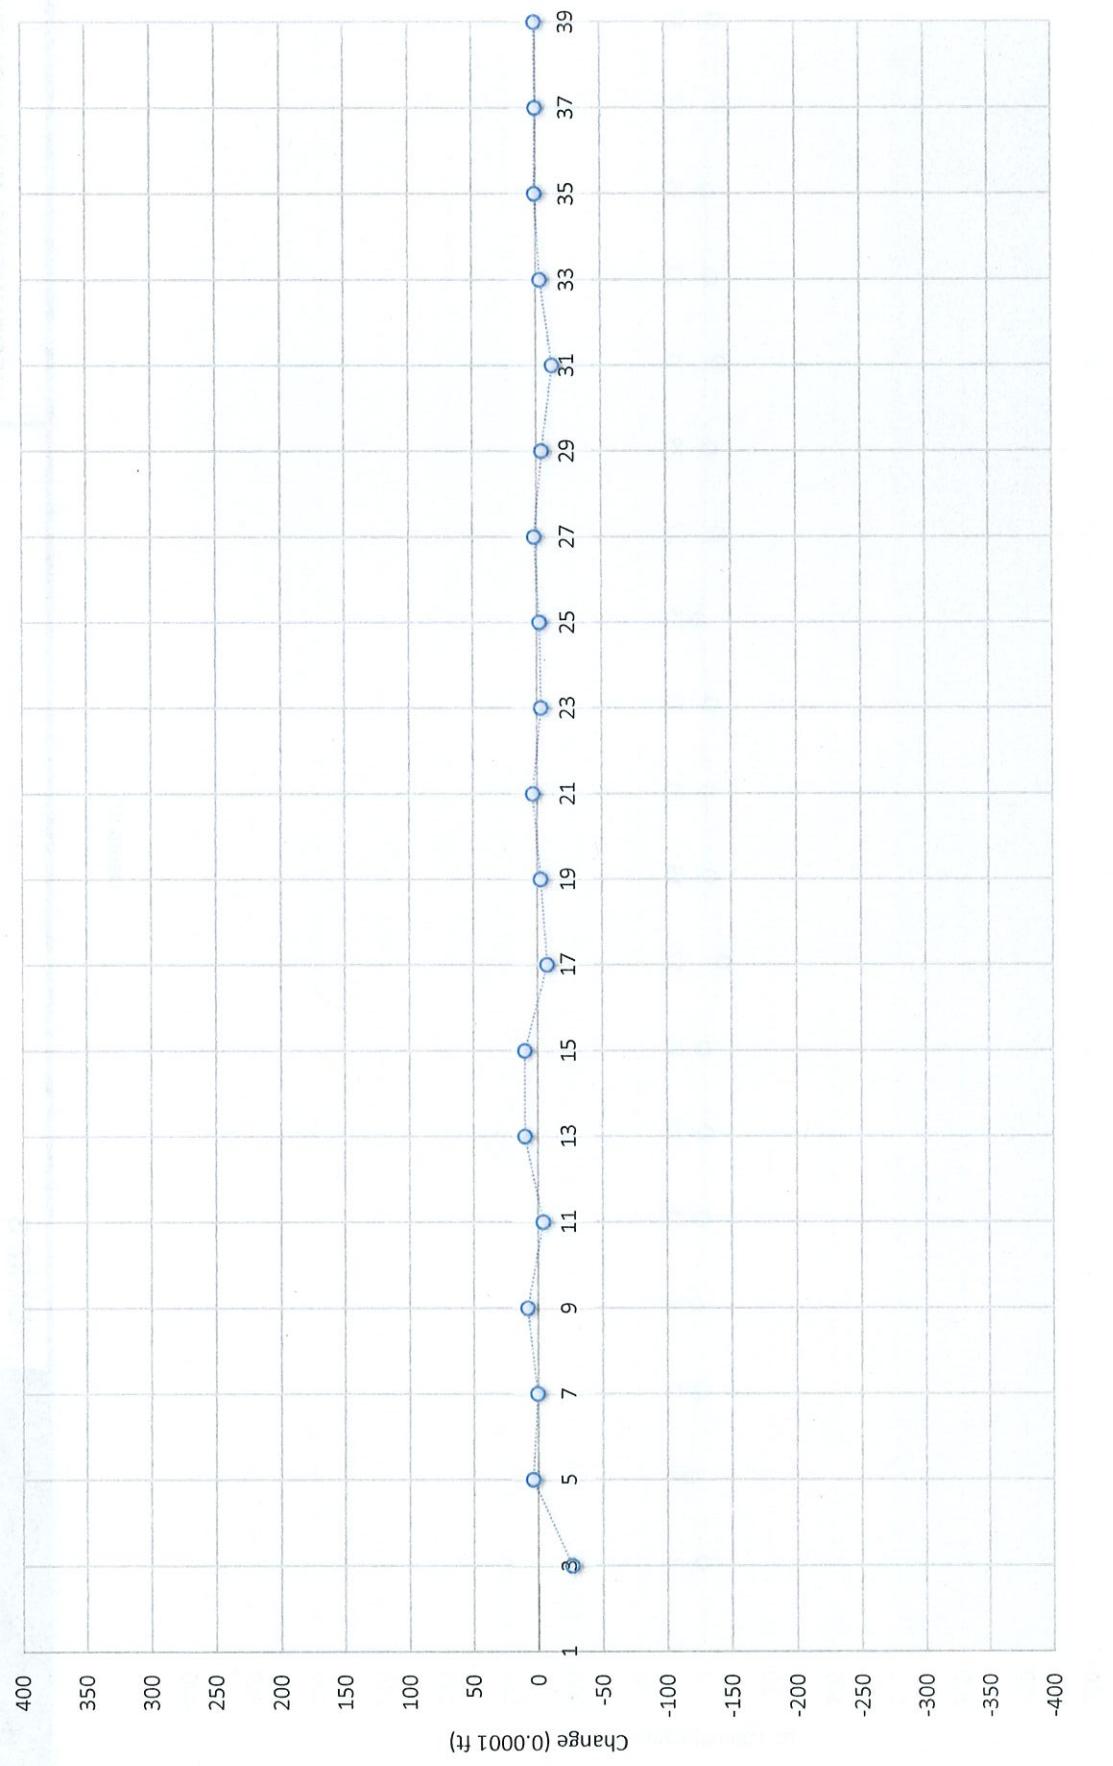
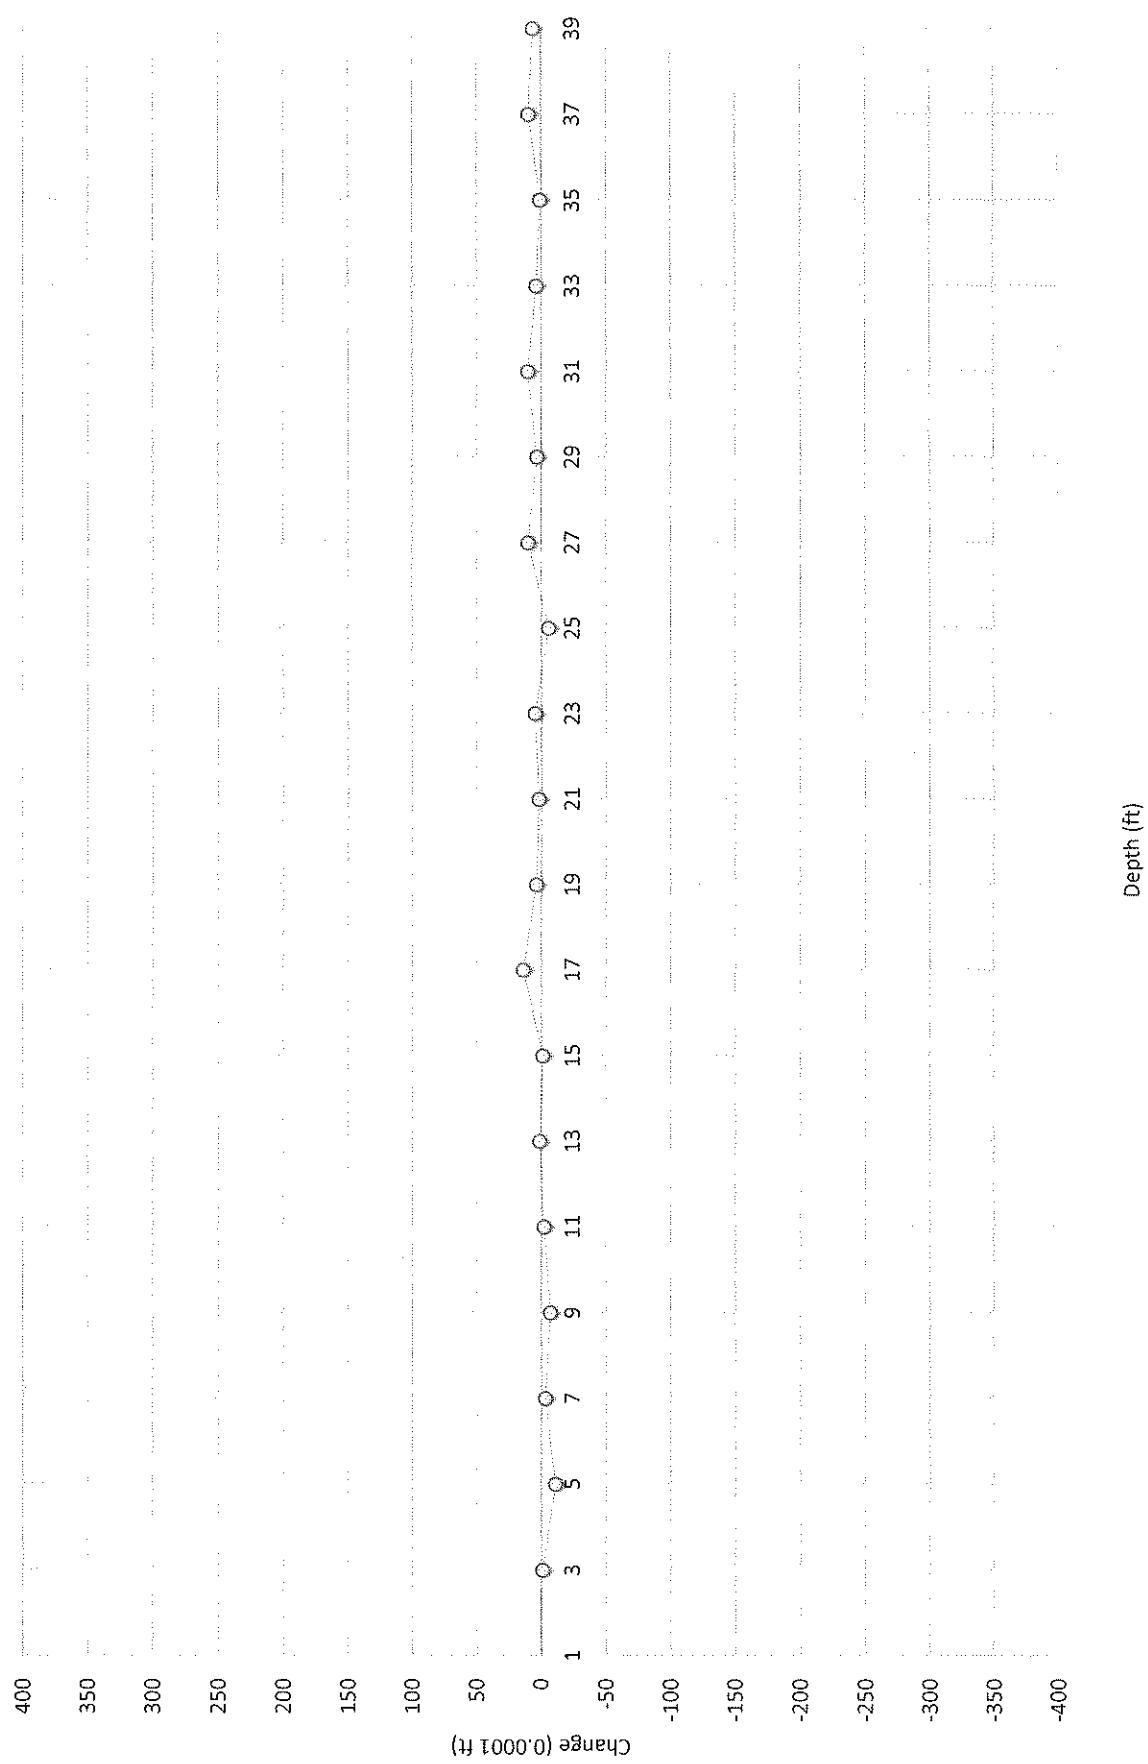
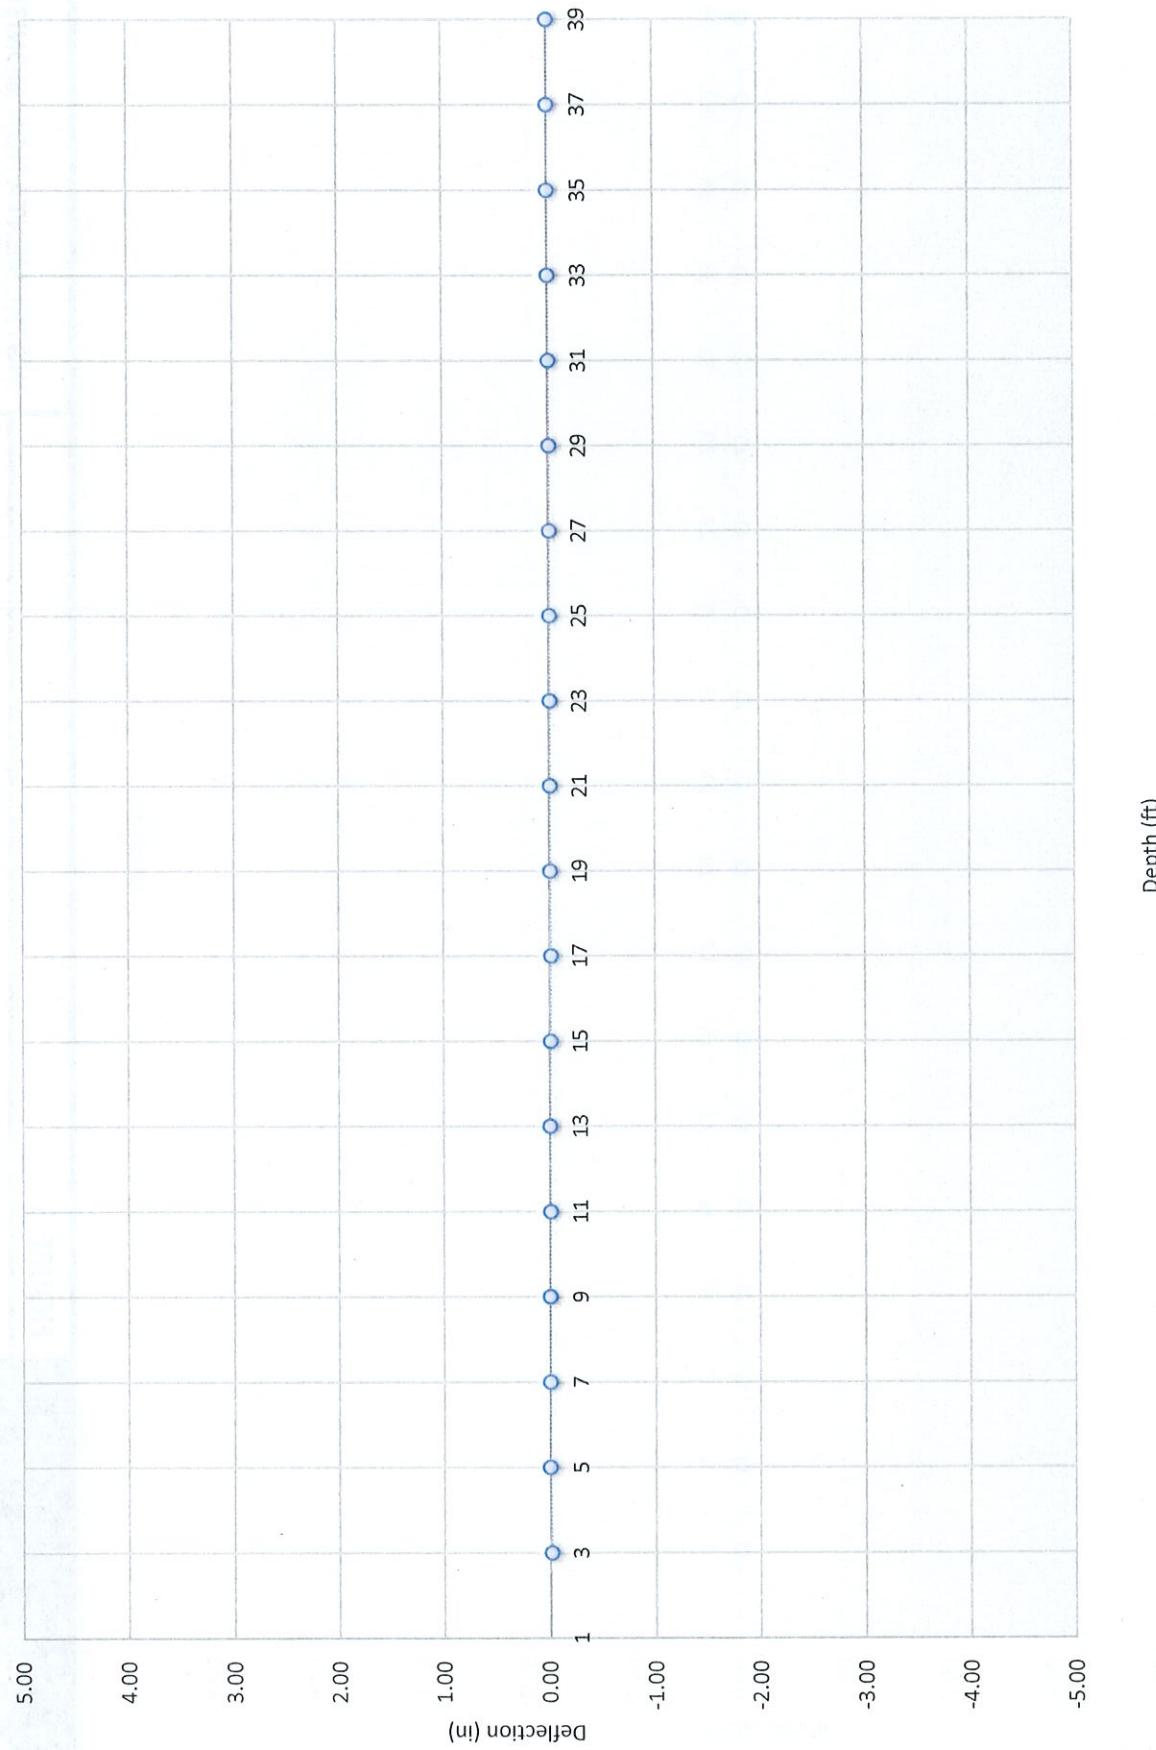
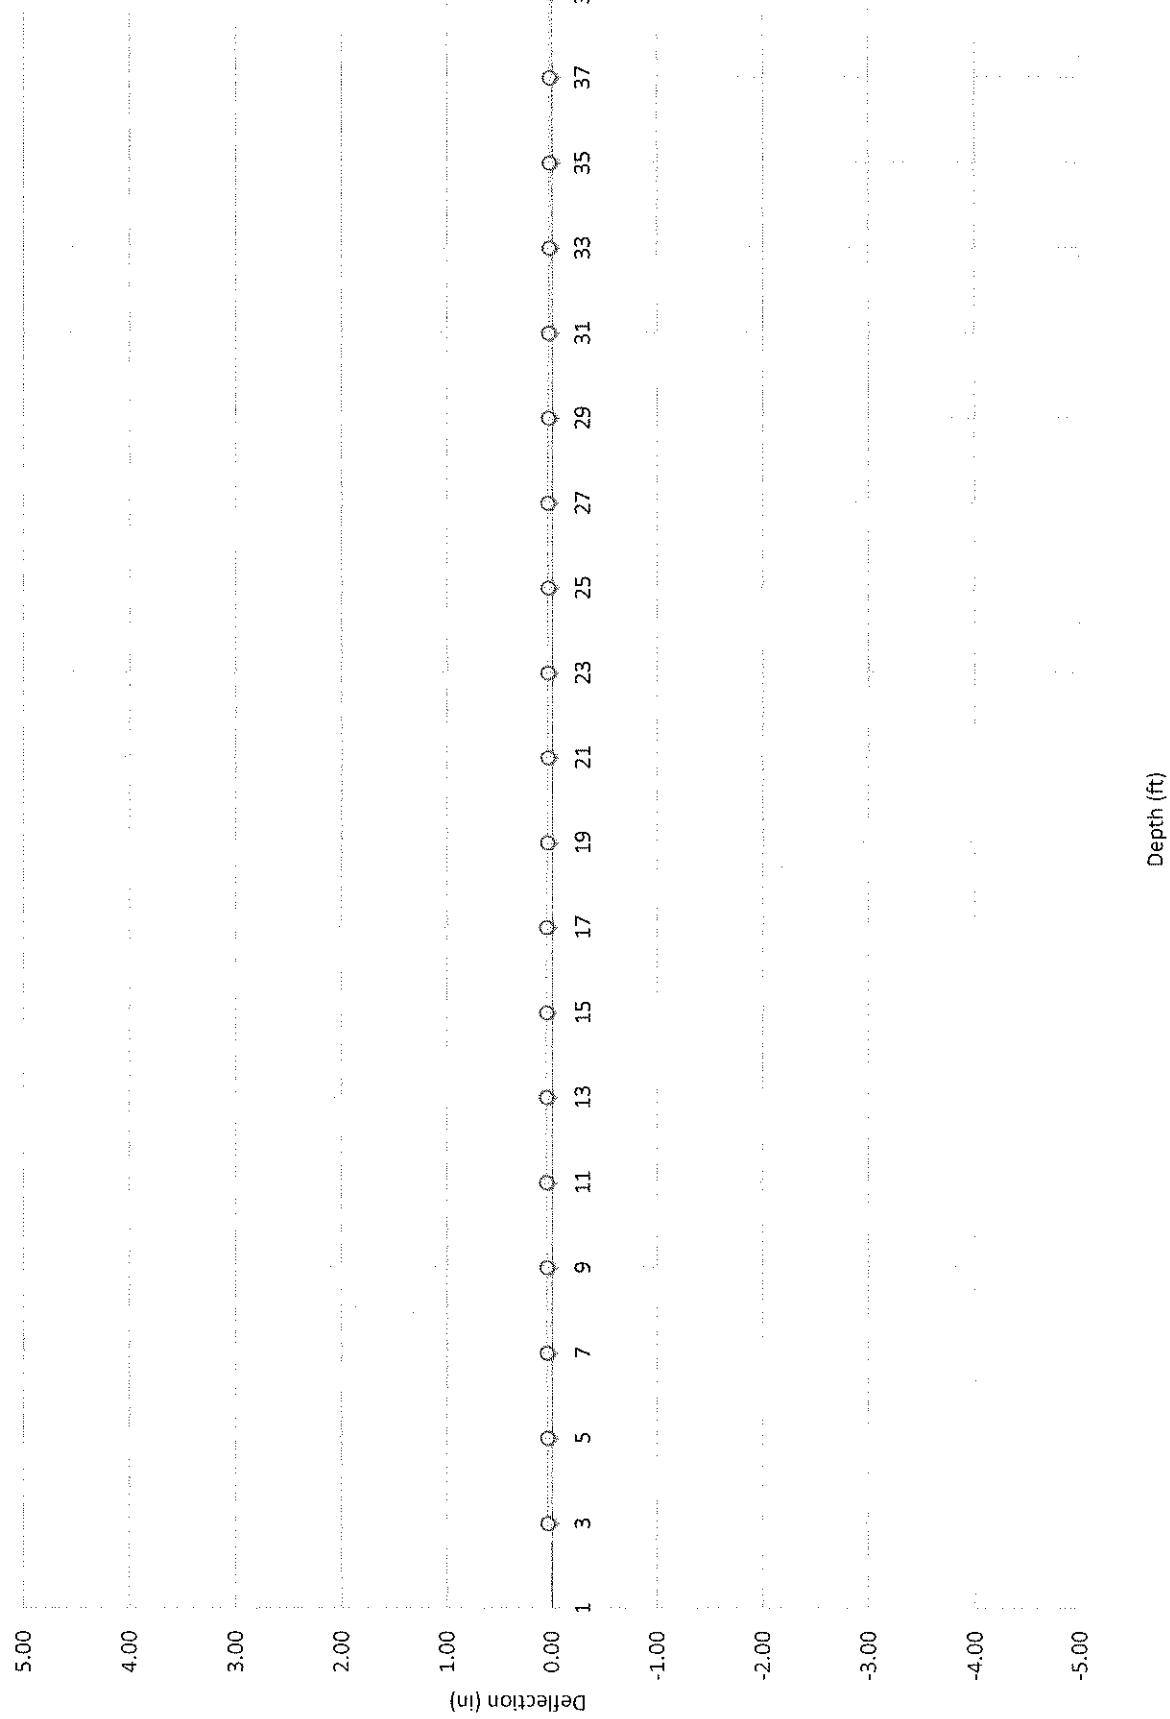
- Inclinometer I-2 (Bor. 5) was installed in August 2017 to substitute previous inclinometer I-2 which was broken (see written communication of August 21, 2017). The reading of January 10, 2018 is the first reading taken from this inclinometer after the base reading. The January 10, 2018 reading indicates that no significant ground movements have developed in this area between months August 2017 to January 2018. Additional readings will be required to confirm this condition.

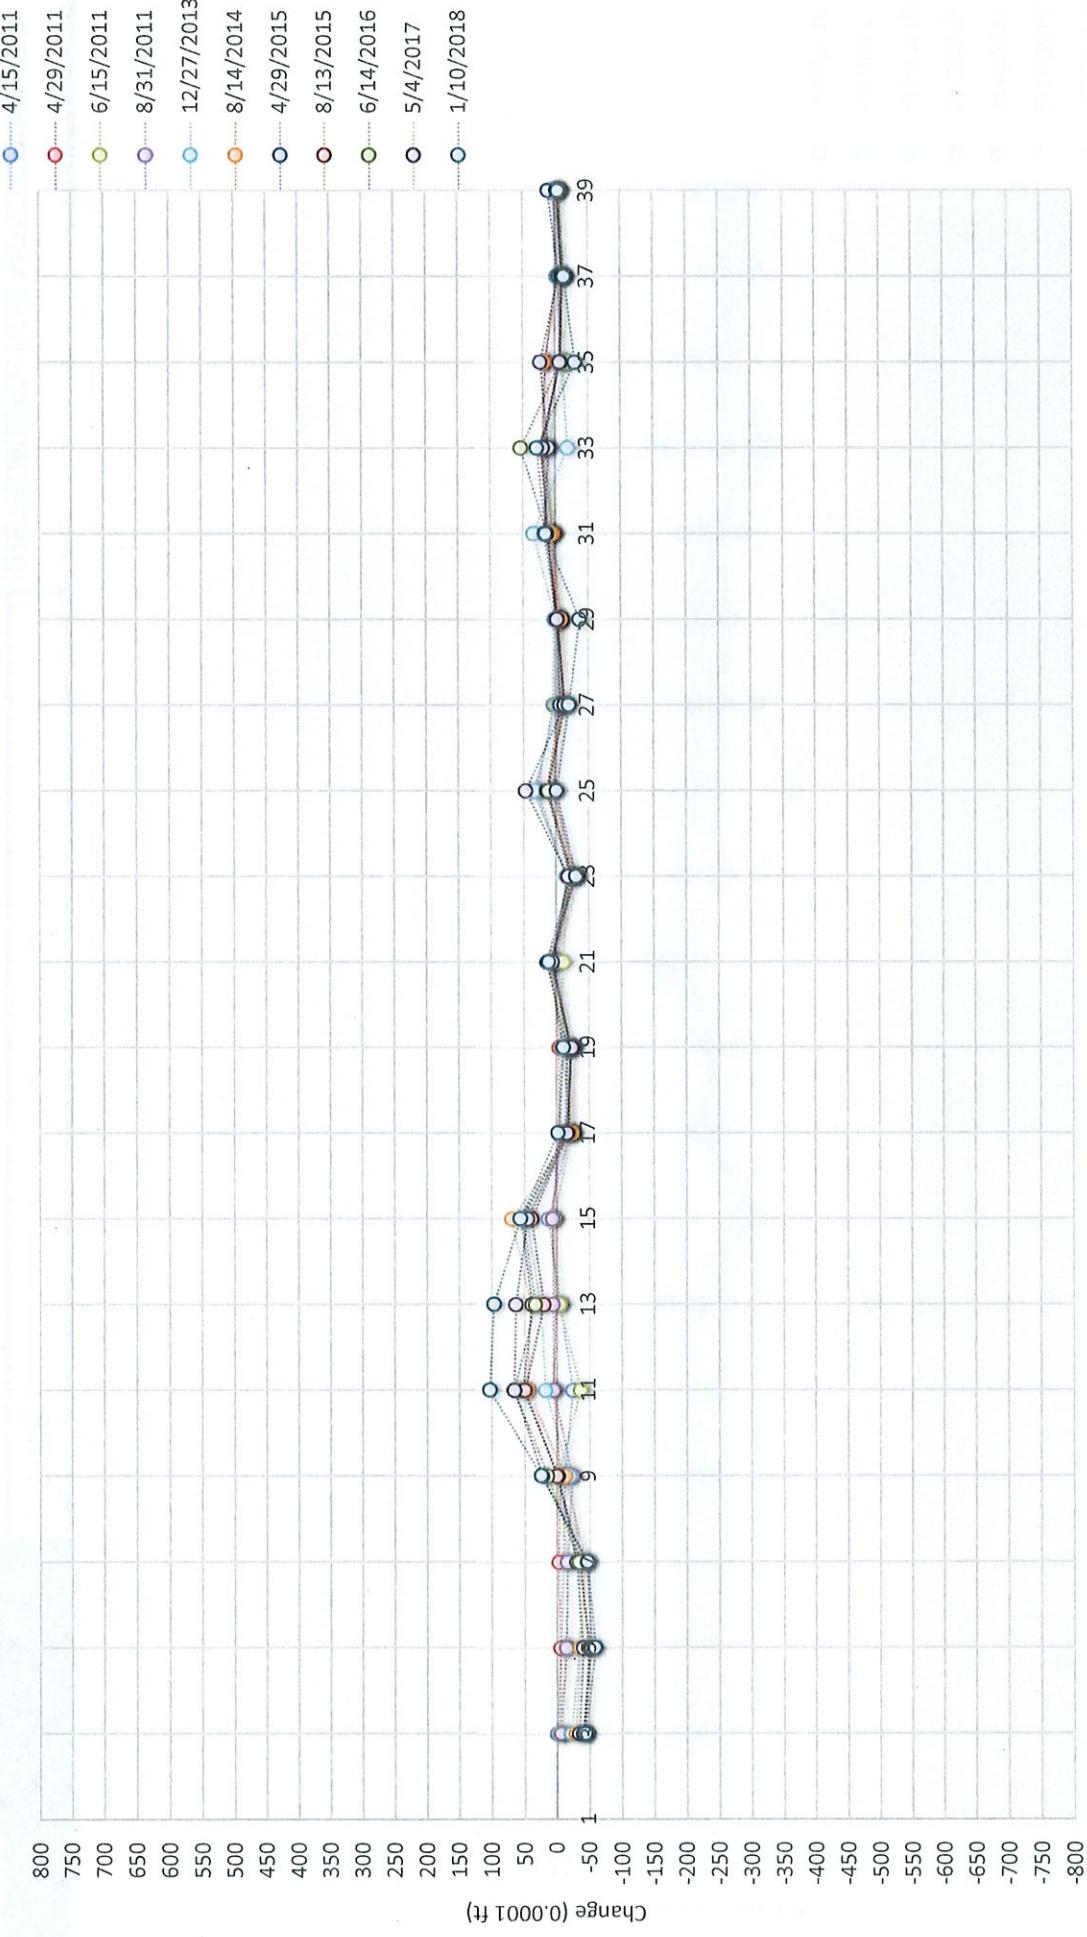
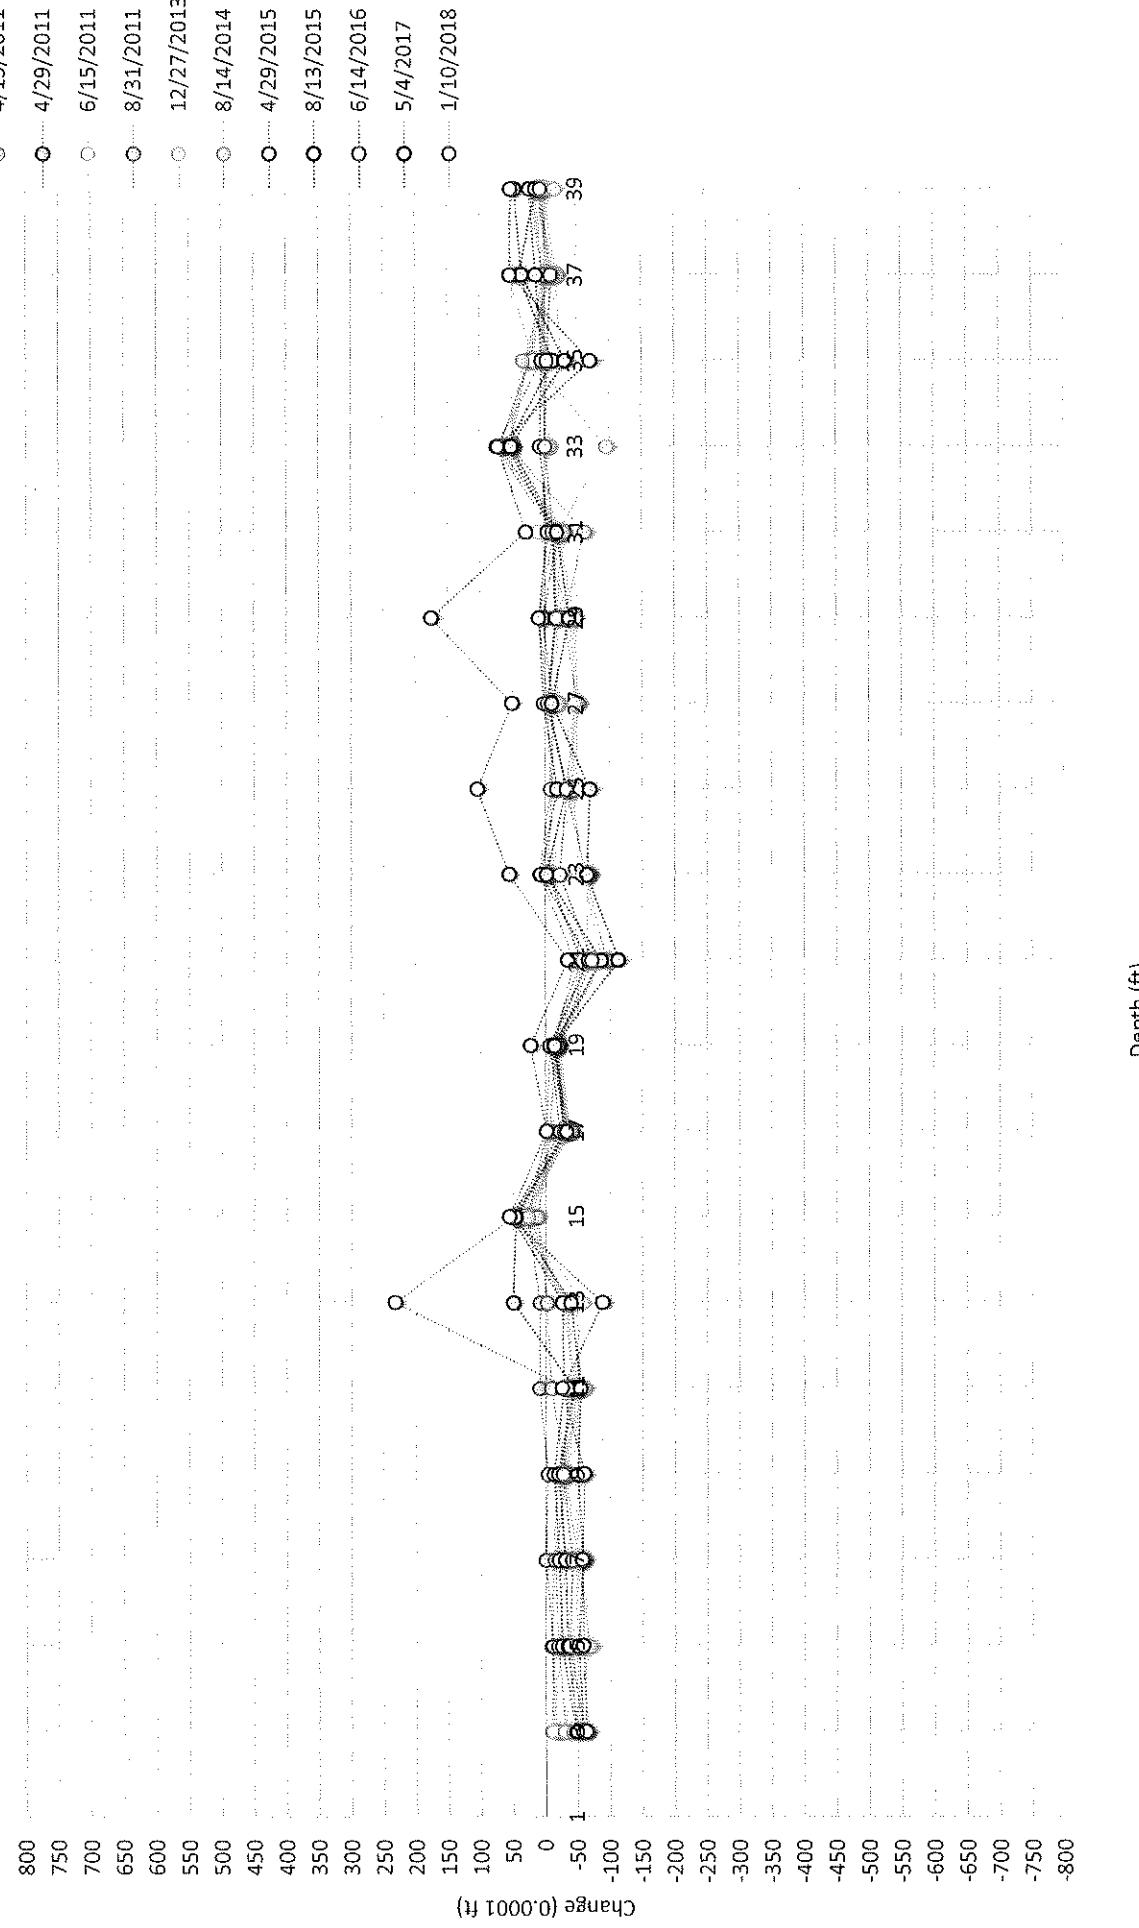
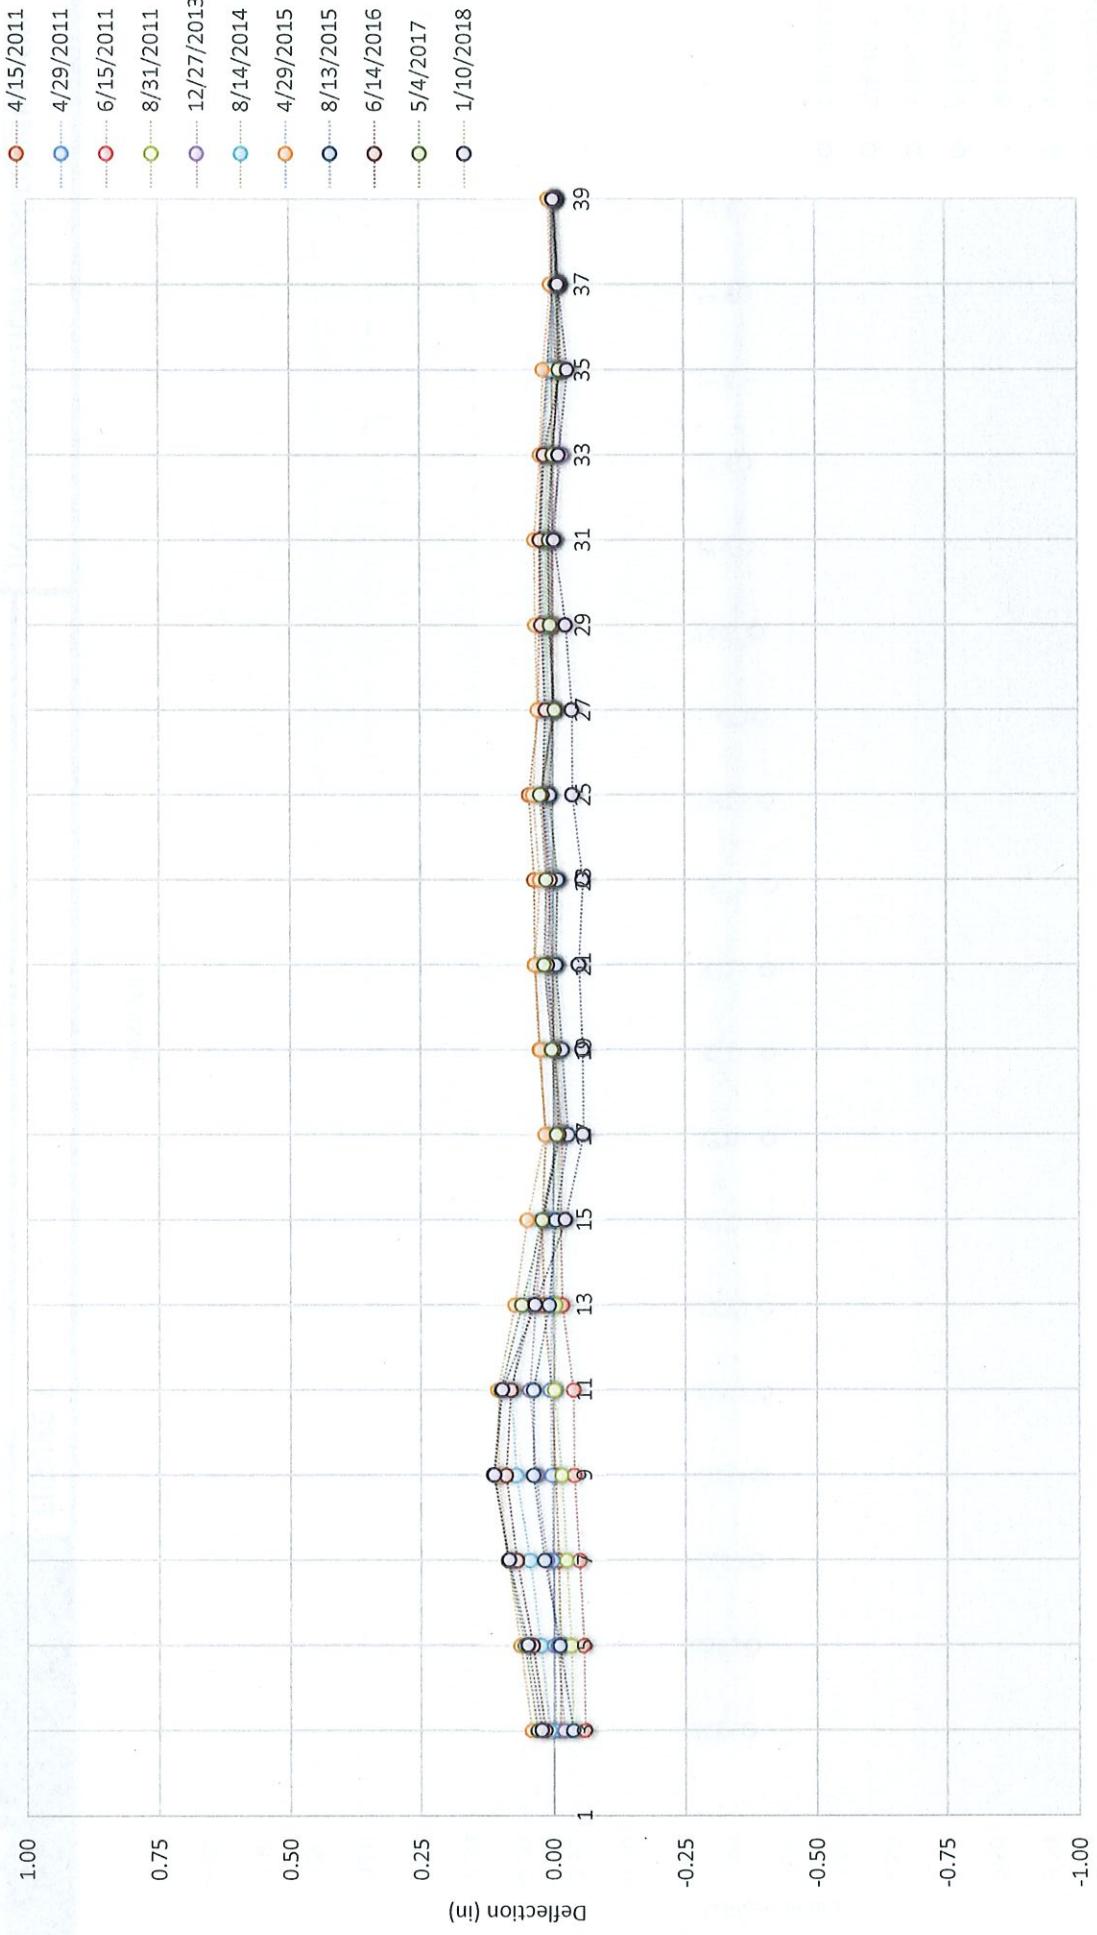
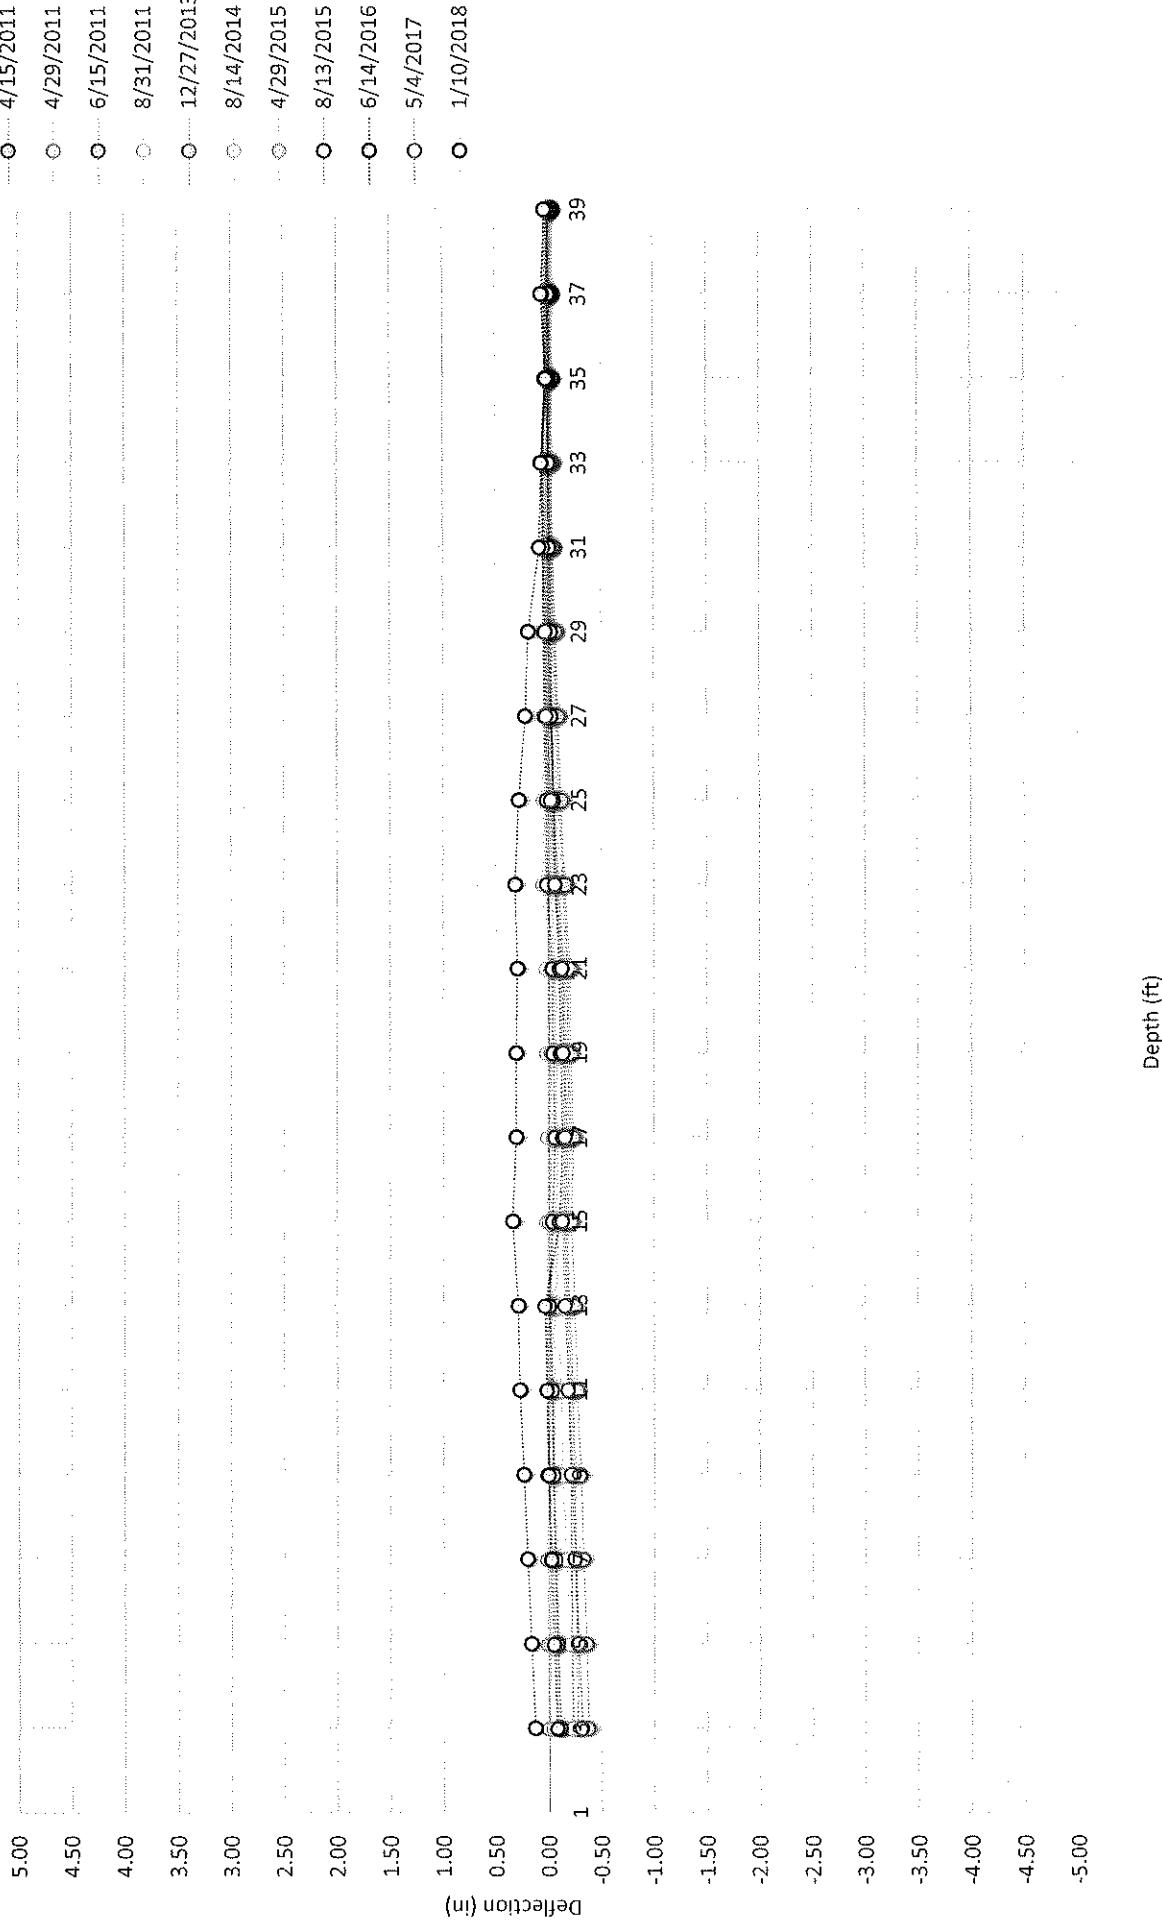
- The reading from inclinometer I-3 is consistent with the previous readings and continues to indicate that the inclinometer casing has maintained minor deformations in the downslope direction between the depths of approximately 11 ft and 15 ft. Based upon the boring log for this inclinometer (boring B-3), the casing has deformed within solid waste found between an upper layer of fill and the underlying in-situ soil. As a result, the detected deformation is probably due to buckling of the inclinometer casing caused by vertical and/or lateral deformations developing within the solid waste. The maximum deflection reached by the inclinometer casing in almost seven years of monitoring is less than  $\frac{1}{8}$  of an inch. No cracks were observed at the ground surface surrounding the inclinometer that would indicate that large lateral movements were occurring within the ground.
